PERFORMANCE CHARACTERIZATIONS OF EURECA RETROREFLECTORS WITH FLUOROPOLYMER-FILLED SiO_x PROTECTIVE COATINGS

NASA Lewis Research Center

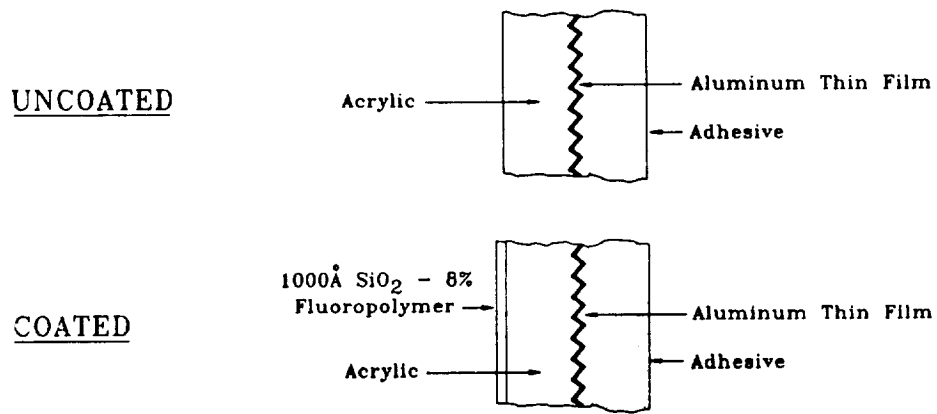
Figure 1. Cross section of uncoated and coated EURECA retroreflector material.

The corner cube retroreflectors used for range finding on the EURECA mission consisted of 15.3 cm x 15.3 cm x 0.22 mm thick sheets of aluminized acrylic reflector material with an adhesive backing for attaching to the EURECA spacecraft. A cross section of the retroreflector configuration for both the uncoated and coated configuration ultimately used is shown in Figure 1. Both approximately 1000Å of SiO_x (where $1.9 < x < 2.0$) and approximately 1000Å of 8% fluoropolymer-filled SiO_x were evaluated for adhesion to acrylic for retroreflector applications. The fluoropolymer-filled SiO_x was found to be more spall resistant than pure SiO_x coatings; and for this reason, was selected for deposition on the EURECA retroreflectors. Deposition of the 8% fluoropolymer-filled SiO_x coating was accomplished by means of argon ion beam sputter co-deposition from a circular SiO₂ target which had a 5° PTFE Teflon wedge placed on top of it to permit both SiO_x and fluoropolymer scission fragments to deposit on the retroreflector substrates. Deposition of approximately 1000Å was accomplished in approximately 35 minutes of sputter deposition after initial argon ion precleaning. Sputter precleaning was accomplished by a second ion source (designated as 15 cm ion source) as shown in Figure 2. Descriptions of the improved strain-to-failure properties of such fluoropolymer-filled coatings can be found in references 4 and 6. Samples of EURECA retroreflector material were coated with approximately 1000Å of 8% fluoropolymer-filled SiO_x and exposed to atomic oxygen along with uncoated laser retroreflector material in a 13.56 MHz RF plasma asher operated on air to a Kapton effective fluence of 3×10^{20} atoms/cm². This exposure was performed to evaluate the optical performance of both the protected and unprotected EURECA retroreflector material to the estimated atomic oxygen mission fluence requirement.

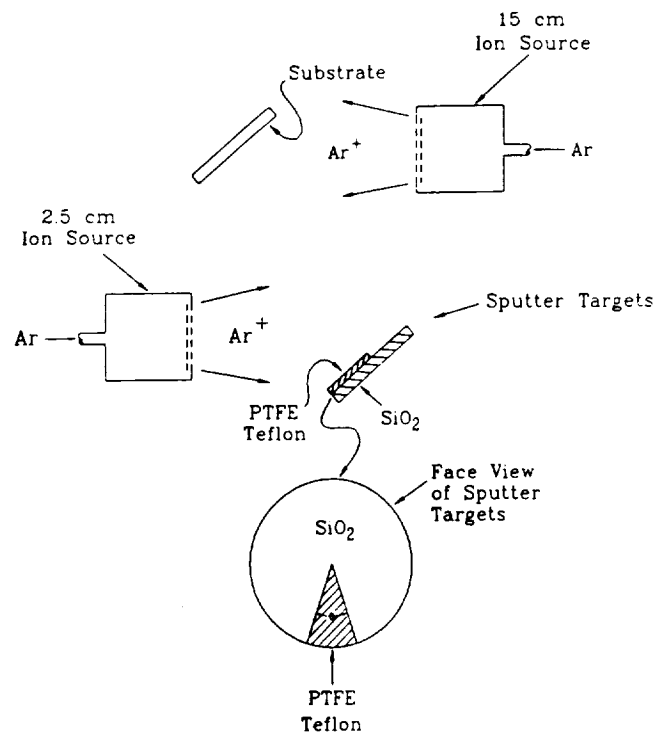
Figure 2. Ion beam sputter coat deposition process for deposition of fluoropolymer-filled SiO_x protective coatings.

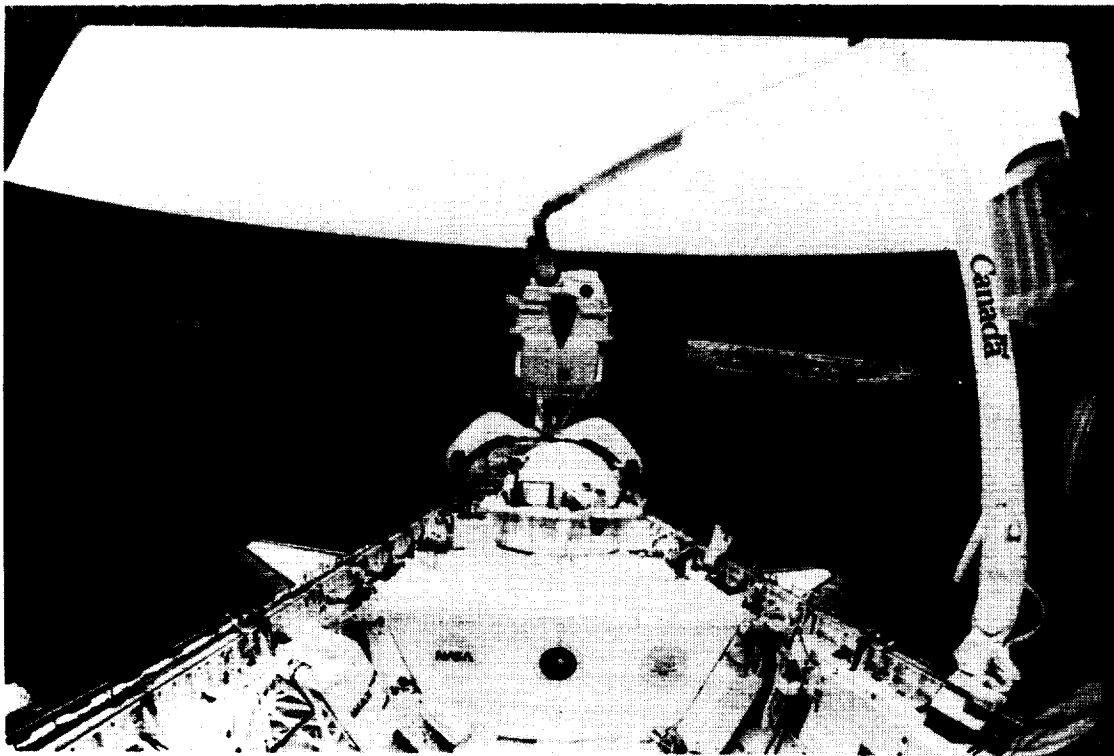
Figure 3. Photograph showing the two laser retroreflectors on the EURECA spacecraft as it is being deployed from the cargo bay of the Space Shuttle on August 2, 1992.

Two coated retroreflectors were then provided for attachment to the EURECA spacecraft scuff plate during the spacecraft integration activities. The EURECA spacecraft was deployed from the Space Shuttle Orbiter cargo bay on August 2, 1992, and retrieved after eleven months in space on June 24, 1993, with a total atomic oxygen fluence of 2.3×10^{20} atoms/cm² exposure to the scuff plate surfaces. The scuff plates containing the two retroreflectors were then removed and post-flight optical characterization was performed at Astrotech Corporation on August 3 and 4, 1993. Figure 3 is a photograph of the EURECA spacecraft showing the retroreflectors on the spacecraft as it is being deployed from the Shuttle bay.

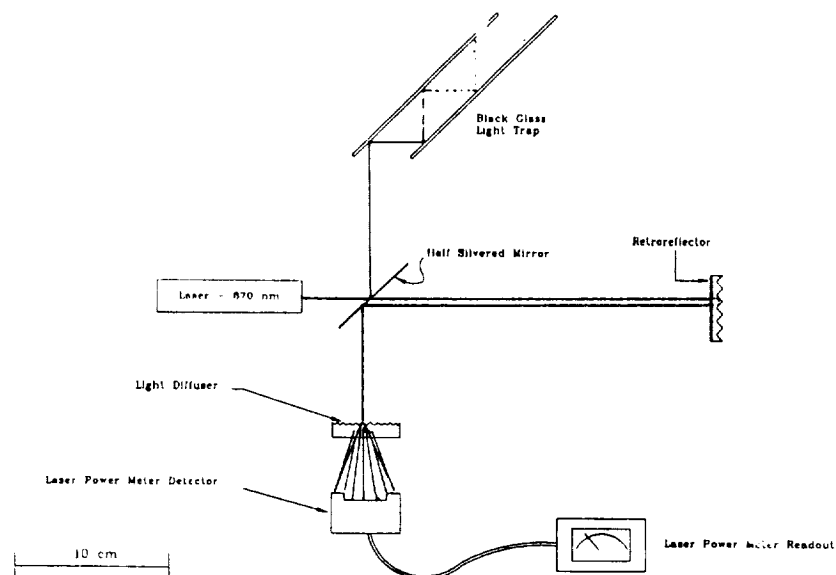
Figure 4. Optical system used to measure the retroreflectance of the EURECA retroreflectors.

Optical characterization of retroreflector materials cannot be reliably accomplished by conventional diffuse or specular reflection measuring techniques because the specular reflection occurs directly parallel to the incoming illumination. This situation frequently prohibits accurate measurement of the return signal. As a result of this complication, it was necessary to construct an optical measurement system which was specifically designed to measure retroreflectance as opposed to conventional specular or diffuse reflectance. Measurement of the retroreflectance was accomplished by using a 670 nm laser and laser power meter in conjunction with a half-silvered mirror as shown in Figure 4. A sand-blasted fused silica window was used as a light diffuser in front of the laser power meter detector to reduce effects of spatial variations in the output of the laser power meter detector. Such spatial variations occur if a narrow beam laser signal arrives at various locations on the laser power meter detector surface. To prevent the laser power meter from viewing reflected illumination, two welders-glass light-trap surfaces were used to absorb the reflected beam by means of multiple reflections and absorptions. A schematic diagram of the optical characterization apparatus is shown in Figure 4. This measurement system was placed in an opaque black cloth enclosure with a hole in it to allow the exit and return of the laser signal, while preventing stray light detection.

Laser retroreflectance characterization of the space-exposed coated EURECA retroreflector materials is shown in Figure 8. This figure compares retroreflectance performance as measured by the optical system shown in Figure 4 for EURECA retroreflector material samples that were coated and space-exposed, coated but not exposed, uncoated and unexposed, coated and plasma asher exposed, uncoated and plasma asher exposed, and the matte abraded spot on the space-exposed retroreflector. Because the standard deviation in retroreflectance for the four high absolute-reflectance surfaces was found to be approximately 6% of their reflectance values, one can conclude that the coated and space-exposed retroreflector had an optical performance indistinguishable from coated samples exposed in a plasma asher. However, unexposed samples which were uncoated or coated had reflectances which were 11 or 17% higher respectively. It is obvious from Figure 8 that unprotected retroreflector materials or protected retroreflector materials whose protection has been abraded away both result in severe loss in retroreflection after exposure to atomic oxygen. These quantified results are also qualitatively witnessed in Figure 5, for the laboratory atomic oxygen environment, and Figure 6b, for the space-exposed atomic oxygen environment results. As can be seen in Figure 6b, the right retroreflector does have a dark spot where the abrasion had damaged the optical performance.

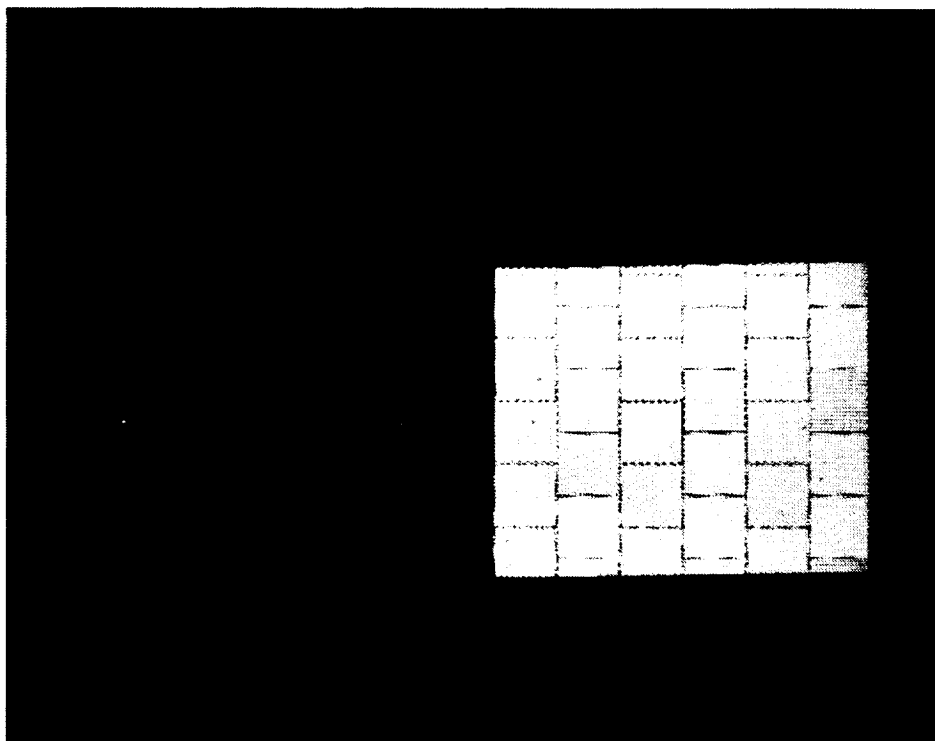
Figure 5. Photograph of uncoated (dark image on the left) and approximately 1000Å thick 8% fluoropolymer-filled SiO_x coated (bright image on the right) EURECA retroreflector samples after exposure to a Kapton effective atomic oxygen fluence of 3×10^{20} atoms/cm².

An 8% fluoropolymer-filled SiO_x ($1.9 < x < 2.0$) protective coating approximately 1000Å thick was found to be durable (based on optical microscope inspections) to atomic oxygen in an RF plasma asher after exposure to a Kapton effective fluence of 3×10^{20} atoms/cm². In contrast, unprotected EURECA retroreflector samples were significantly attacked by atomic oxygen, resulting in a surface with diffusely scattered light, thus greatly attenuating the intensity of retroreflected light. Figure 5 is a photograph of uncoated and 8% fluoropolymer-filled SiO_x coated EURECA retroreflector materials after exposure to atomic oxygen to a Kapton effective fluence of 3×10^{20} atoms/cm² in an RF plasma asher operated on air. The photograph shown in Figure 5 was taken by simultaneously illuminating both samples in a direction parallel to the camera viewing direction. Thus the brightness of the sample, as viewed from the direction of the incident light, is a direct indication of the optical performance of the retroreflectors. The uncoated sample appears dark because it diffusely scattered the incident radiation. The bright protected sample appears bright because it confines its reflected radiation to a specular path

parallel to the incident illumination. However, if one views these two samples from a direction other than parallel to the incident illumination, then the atomic oxygen degraded uncoated sample appears much brighter than the protected sample because of significant scattering of the incident illumination from the rough surface of the unprotected sample.

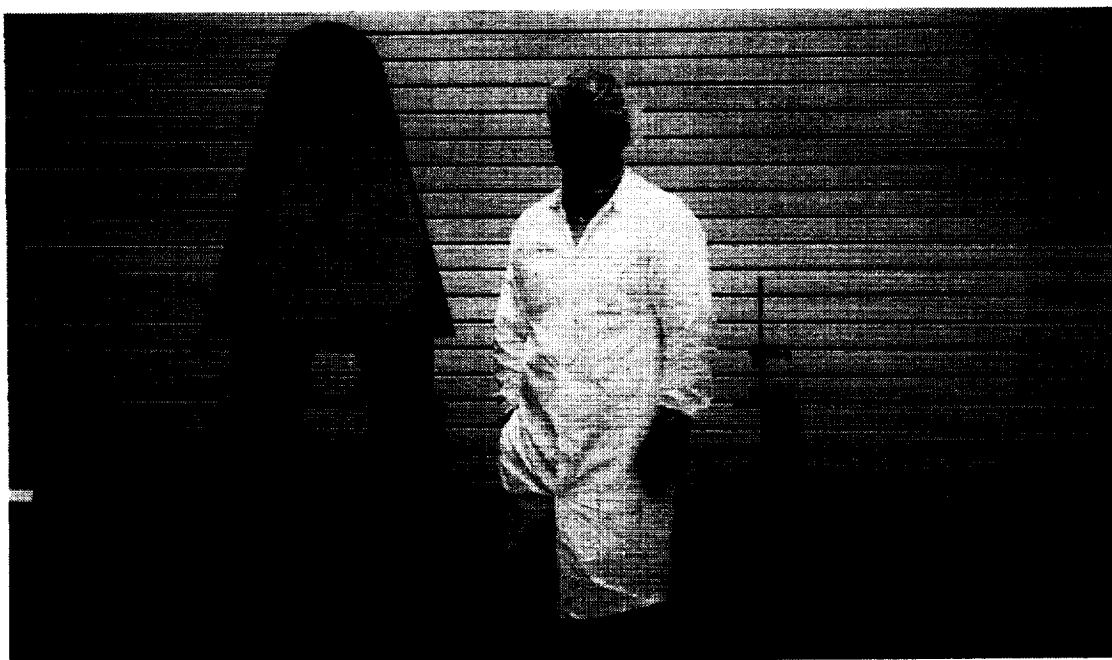
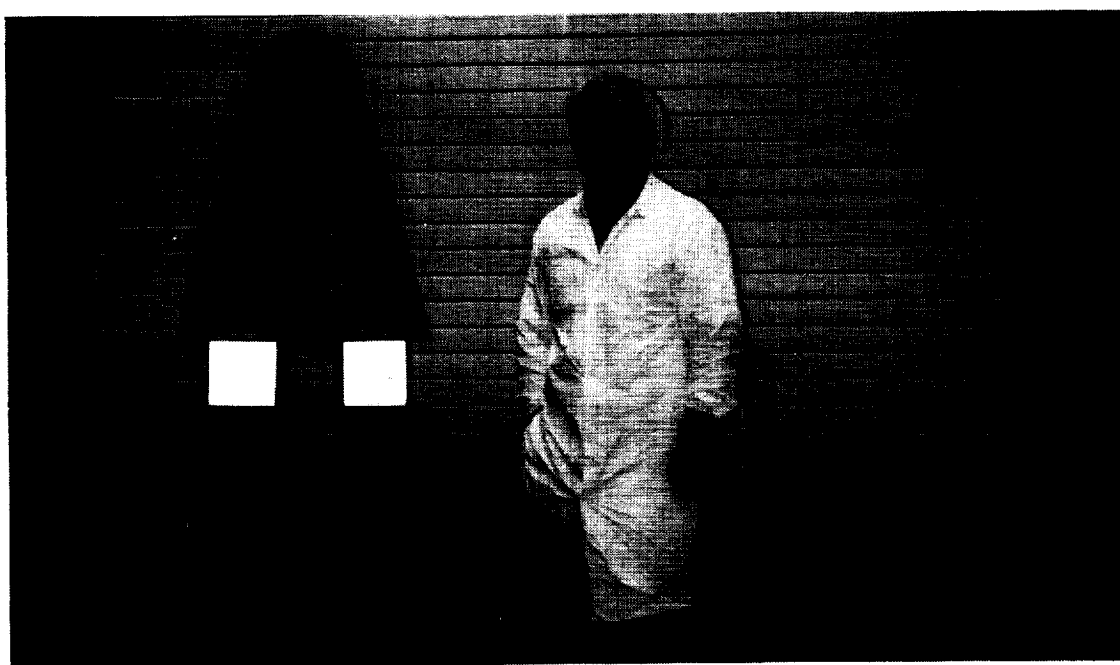
Figure 6a. Photographed with ceiling illumination only.

Figure 6b. Photographed with ceiling illumination and incandescent lamp illumination parallel to the camera viewing direction.

Figure 6. Fluoropolymer-filled SiO_x protected EURECA laser reflectors mounted on the EURECA scuff plate after retrieval from in-space exposure.

After exposure in space to an atomic oxygen fluence of 2.3×10^{20} atoms/cm², the EURECA laser retroreflectors were fully functional, as can be seen in Figure 6. By comparison of Figures 6a and 6b, one can see that the retroreflectors remained capable of returning a bright specular retroreflection signal. Figure 7 shows a close-up photograph of the retroreflector on the left in Figures 6a and 6b. To the unaided eye, the surface of this retroreflector appeared indistinguishable from samples which were not exposed to the space environment. The right retroreflector appeared identical to the left retroreflector except for a small patch 3 cm in diameter where the protective coating had been damaged by abrasion during pre-flight spacecraft integration activities. Apparently, a bolt adjacent to the scuff plate had to be sawed off, causing repeated contact with the retroreflector in this small area. Although this surface-damaged area was then attacked by atomic oxygen, it provided an ideal opportunity to assess the detrimental effects of atomic oxygen exposure in space to retroreflector material which was not adequately protected.

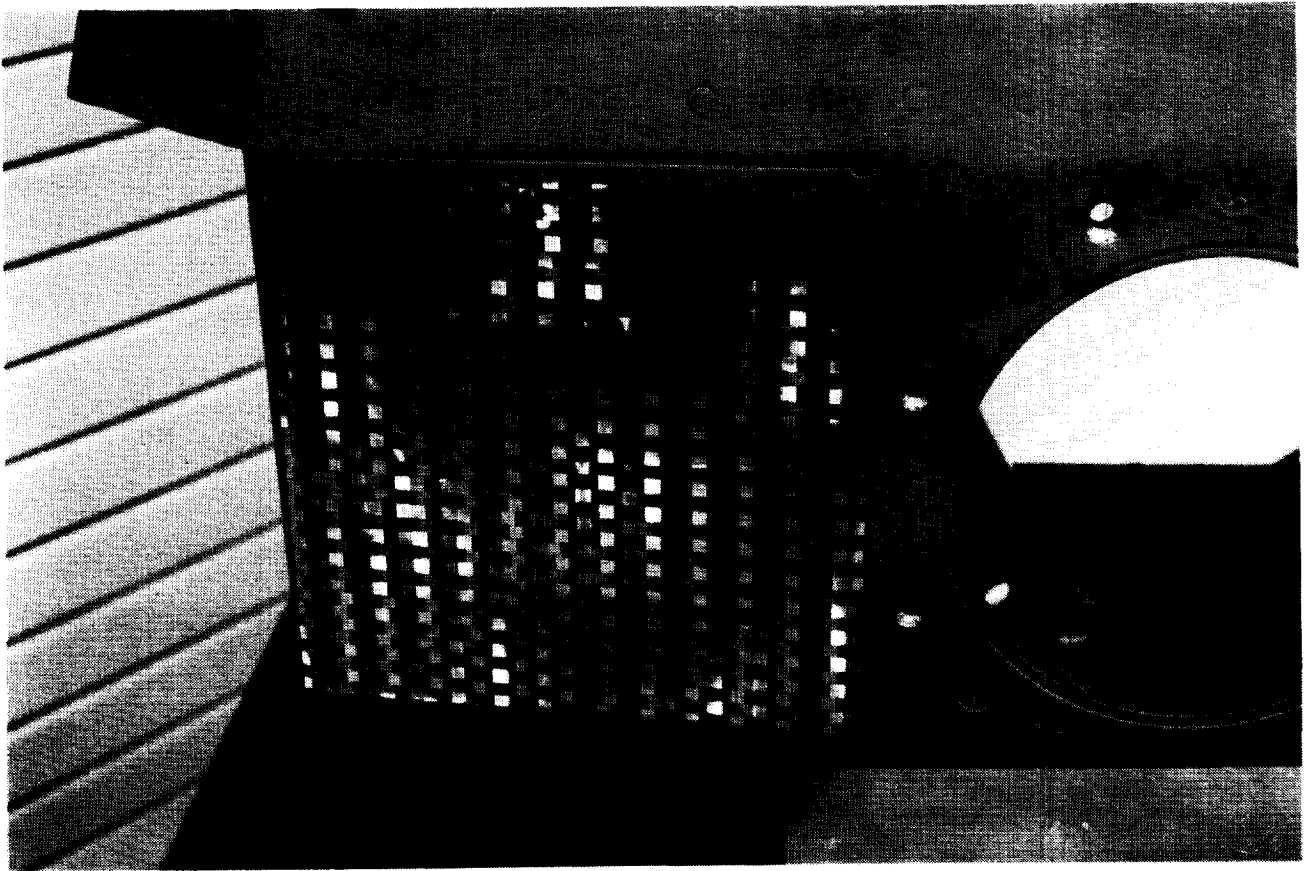
Figure 7. Close-up photograph of left EURECA retroreflector after retrieval from space.

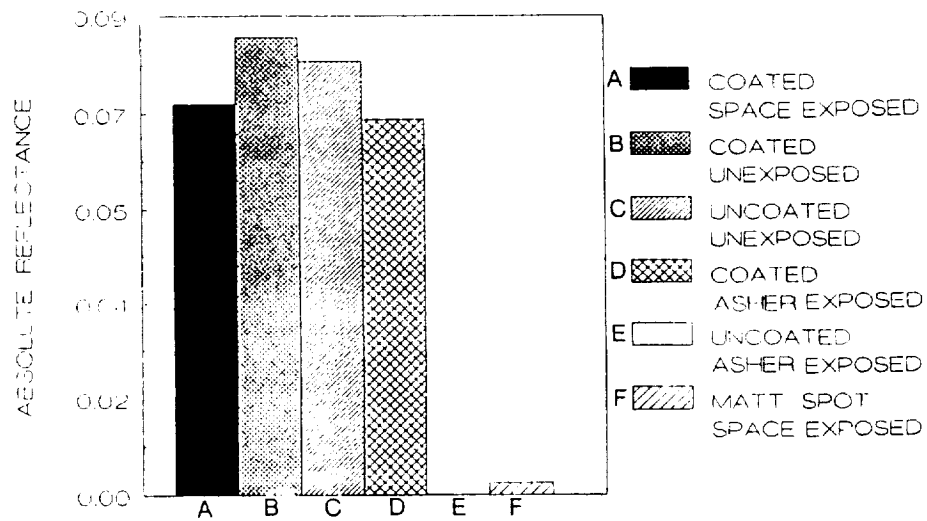
Figure 8. Comparison of optical performance of EURECA retroreflector materials for 670 nm illumination.

The optical performance data illustrated in Figures 8 and 9 were for normal-incident laser radiation. In the realistic environment of space, it is unlikely that laser range finding acquisition will occur at normal incidence to the retroreflectors. Thus, it is important that the retroreflectance signal be high even at off-normal incidence to provide a strong return signal. The range finding was successfully accomplished on EURECA, with the retroreflectors providing a bright visual return signal. Figure 10 compares the retroreflectance relative to normal incidence as a function of angle of illumination relative to the surface normal for the various retroreflector surfaces. As can be seen from Figure 10, the EURECA coated and space-exposed retroreflectors had an angular dependence which was indistinguishable from pristine retroreflector surfaces or ones which were coated and exposed to a simulated low Earth orbital environment using RF asher plasma atomic oxygen.

Based on the astronauts' satisfaction with the performance of the retroreflectors, as well as the quantified optical performance shown in Figures 8, 9, and 10, one can conclude that atomic oxygen protection is needed and that 8% fluoropolymer-filled SiO_x protective coatings provide excellent atomic oxygen protection of acrylic retroreflector materials for atomic oxygen fluences up to 2.3×10^{20} atoms/cm².

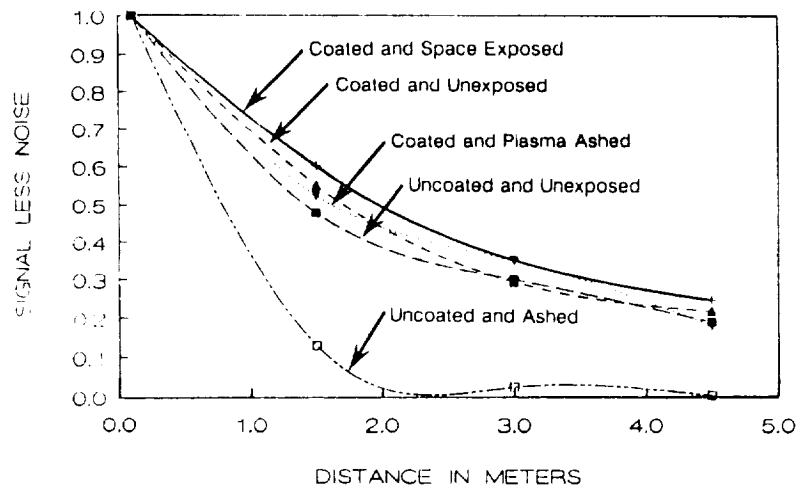
Figure 9. Retroreflector optical performance for coated and space exposed, coated and unexposed, coated and plasma ashed, uncoated and unexposed, and uncoated and plasma ashed retroreflector materials illuminated with 670 nm wavelength light.

The degradation in retroreflected signal versus distance is shown in Figure 9 for various retroreflector surfaces and exposures. As can be seen from Figure 9, based on the 6% uncertainty in the retroreflection signals, all the retroreflector materials whose coatings or exposures have prevented erosion of the surface of the retroreflector have somewhat similar reduction in return signal with distance. However, the uncoated plasma ashed surface had a much more significant loss of return signal with distance than the surfaces of unexposed or protected retroreflector materials. The more rapid loss of retroreflectance with distance of the uncoated plasma ashed surface is a result of the significant diffuse scattering from microscopically roughened acrylic surface.

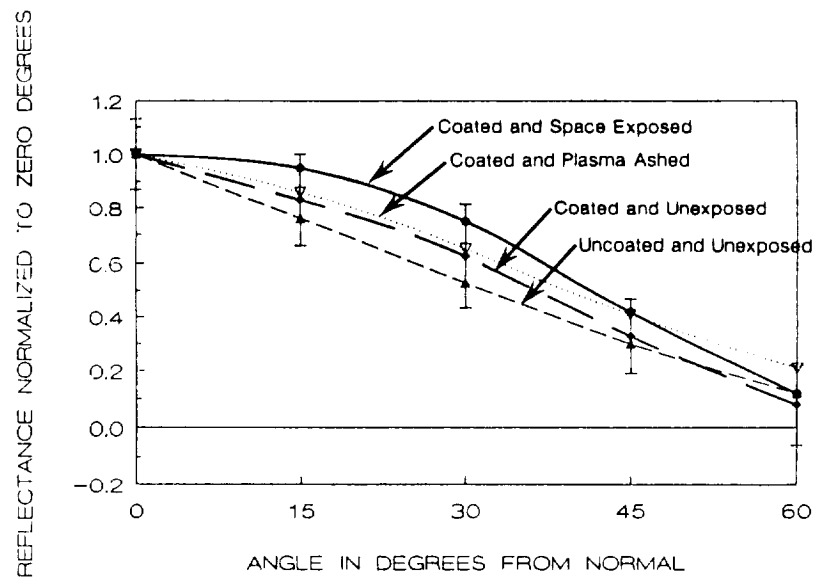
Figure 10. Angular dependence of retroreflectance for coated and space exposed, coated and plasma ashed, coated and unexposed, uncoated and unexposed retroreflector materials illuminated with 670 nm wavelength light.
